BOILER EXPLOSIONS AS AFFECTED
BY UNSYMMETRICAL RIVETED JOINTS.

TYPICAL LAP JOINT BOILER EXPLOSIONS.

By S. H. BARRACLOUGH and A. J. GIBSON.

2. *General description of the Thornton Locomotive Boiler Explosion.*—The first of the two boiler failures referred to occurred near Thornton, N.S.W., on December 5th, 1905, while the engine was running in ordinary service between Maitland and Newcastle. The accident occurred on a down grade when the speed of the train was approximately 40 miles an hour. All the evidence points to the fact that there was no unusual circumstance about the running of the engine prior to the accident. The boiler was carrying its normal pressure of 140 lbs. per square inch, and the safety valves were blowing freely. Subsequent to the accident, the steam gauge and the safety valves were removed from the locomotive and tested, and were all found to be correct and in good order.

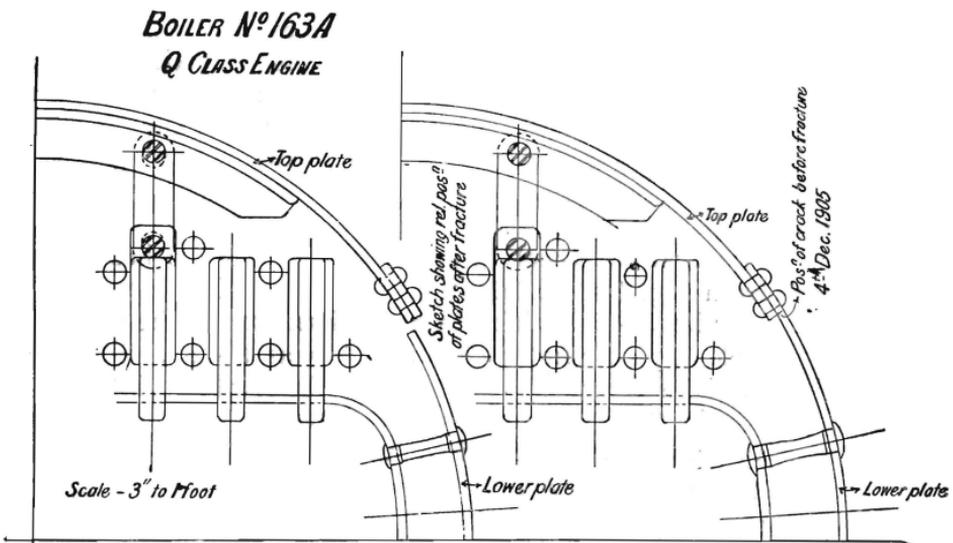
FIG. 1.

unique characteristics. The authors have not come across any record of a fracture of such a length (about 40 inches) so straight that it might almost have been marked out with a rule, and the edges so clean as to suggest the operation of shearing rather than an explosive action. This point is of special interest when comparing the fracture in this plate with the remarkable state of affairs subsequently found to have occurred in a corresponding position on the opposite side plate of the furnace (see § 8). A reference to Fig. 1, which shows a cross section of the fractured plate, will make

clear that the crack began on the inner surface of the outer plate just underneath the landing of the inner plate.

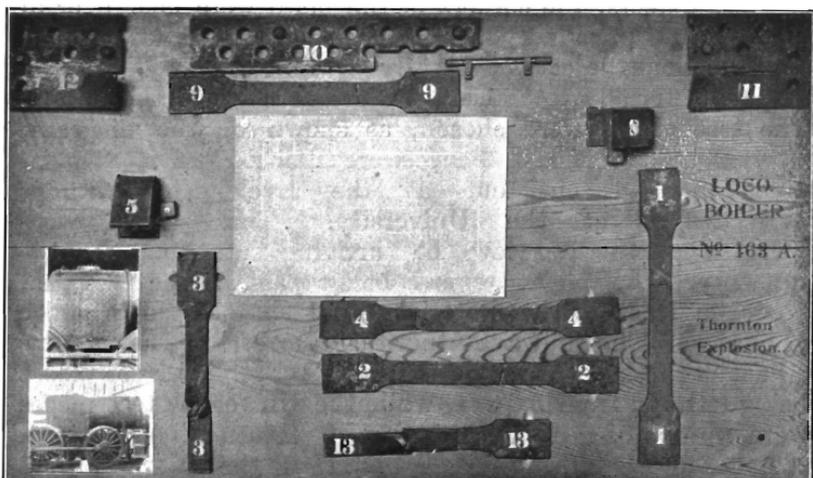
Fig. 2A—Board of Exhibits, Boiler No 163A.

and the fractured plate removed and sent to the University where it was carefully examined as a whole, and the position and nature of the requisite test pieces decided upon. It was apparent on examining the plate in this condition that the actual fracture was not the only crack in the plate, but that there were a few other small ones which had been hidden by the lap and could not be seen by an examination of the plate in situ. The position of these cracks and groovings is shown in Fig. 2, Plate III., from which it will be seen that the main ones form a continuation of the actual fracture, and occur at the edge of the landing. To develop more fully the nature of these defects, the corners of the plate were bent over in an hydraulic press. These cracks and groovings were found to be serious defects, evidently of considerable age, and helped materially to determine the true cause of the failure. The test pieces were chosen, as shown on the diagram, Fig. 2, Plate III. They were marked off for identification and cut out at the Eveleigh workshops and tested at the University. The pieces were selected with a view to arriving at the average quality of the plate, regard being paid to the fact that near the fracture the material might show some evidence of change. The railway authorities also selected specimens adjacent to those taken by the University, their test pieces being lettered from A to H, while the University test pieces were numbered 1 to 13 (see Fig. 2 (Plate III.) and 2A). The corner pieces, marked 11 and 12 in the diagram, were taken for minute examination of the nature of the cracks and grooving developed in them.

The general results of the tests are given in the accompanying table (see Appendix I). They show the plate to be of good average quality, of normal ductility, and to exhibit no marked defect of structure. Fractures of the broken specimen show a clean fibrous structure with slight lamination, but the latter not of such a character as to render the plate unsuitable for high-class boiler construction. The plate was such that it would have been accepted for use on the results of these tests, even if it had been a new one.
