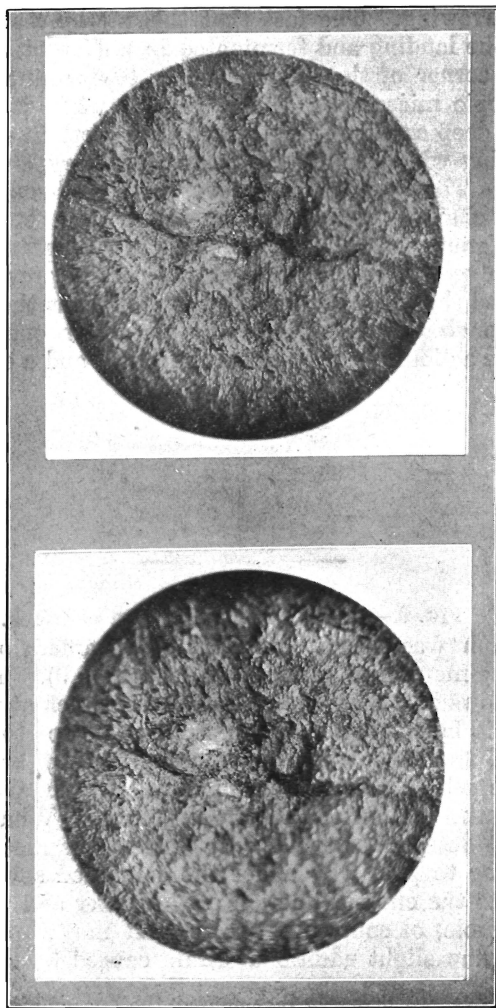
Fig. 9—Stereoscopic Photograph of Pit Hole.

photograph was taken by means of a camera attached to the above-mentioned microscope (see Fig. 9). The photograph shows in a magnified way the fine crack at the bottom of the pit hole, extending longitudinally up towards the edges of the hole where it would gradually break into a similar crack in a neighbouring hole, or join another such crack at the bottom of one of the grooves. What condition it is that determines the precise fibre of the metal which is first going to give way under the combined severe surface strain and the chemical action of the water and the heat, it is impossible, of course, to predict. It may in one case be due to some slight additional strain caused by the caulking

*The authors strongly recommend the use of these low-power stereoscopic microscopes for the examination of cracks and groovings. The double tube portion of the microscope can easily be detached from the stand and supported by one hand when examining the inside of the boiler.

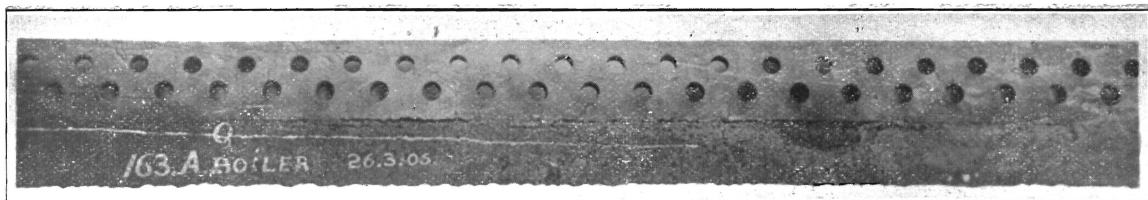
FIG. 10.—View of Upper Portion of Unfractured Plate.

plate, and, in order that the matter might be further examined, the Chief Mechanical Engineer directed the crown plate to be entirely removed so as to leave the side plate quite clear. When this was done, it was seen that there were fine groove marks in one or two spots along the line marked by the edge of the landing; the most prominent of them being the one which had been already located by the scribe point as stated above. The marks, however, were insignificant in appearance and were only such as are commonly seen along the junction line where two plates are riveted together. They were not such as to attract special attention even at this stage, and nine out of ten inspectors examining the plate would have decided, and with considerable justification, that it was quite sound. In fact, it appeared to the authors, although they were, at the time, specifically looking for and expecting a fracture at that spot, that the action could not have proceeded very far, and that the suggestion referred to above, that the failing of the other side of the boiler had relieved this one, was possibly correct.

Fortunately, however, the whole side plate was subsequently removed from the boiler, and the top portion was put under the hydraulic press, when it was found that the plate was fractured from end to end along the aforementioned line, and that the fracture had gone right through the plate almost to the outer skin. A photograph of the whole length of plate, and an enlarged view of portion of it are shown in Figs. 10 and 11. The history of this plate illustrates, in a very striking way, the extraordinary difficulty that besets the boiler inspector who is endeavouring to determine the existence of these fractures. Here was a plate nearly severed throughout its entire length; the edges of the fracture were so close together that its surface, even under minute examination, looked almost as good as new; the line of fracture was almost entirely masked by the overlapping crown plate, and the fracturing had gone on so uniformly that it had approached the skin of the plate on the far side throughout its entire length without piercing it at any one point so as to give warning, and yet it was in such a condition that a very slight shock would have sufficed to break it and let out the contents of the boiler.
