FIG. 12A.—Burwood Boiler from Inside.

DEVELOPMENT OF FRACTURED PLATE OF BOILER  
ON STEAM MOTOR No. 82.  
VIEWED FROM INSIDE.

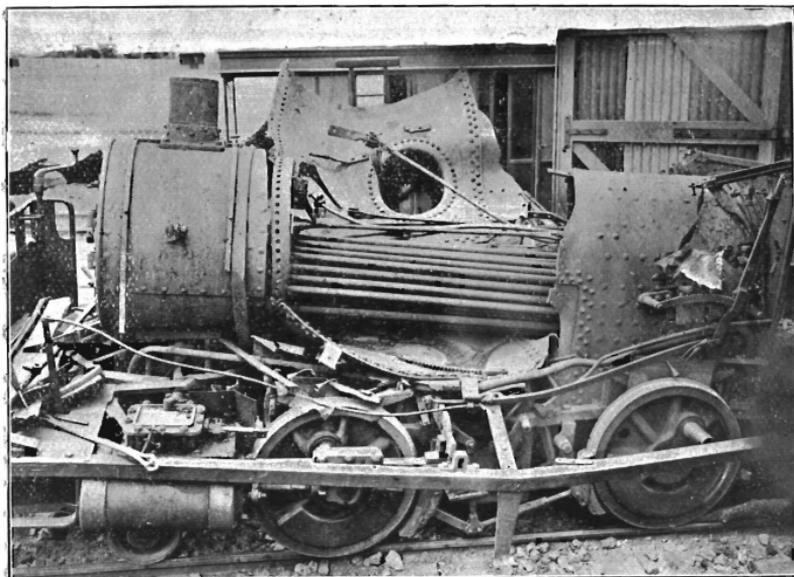
loop near Burwood, where two steam trams had halted to exchange staffs previous to crossing, the two steam motors standing side by side at the instant of the explosion. Boiler No. 82 was completely wrecked (Figs. 12A and 12B) the other motor was severely damaged, and, very unhappily, the accident caused the death of both drivers. In the case of this failure, as in the Thornton one already described, there would appear to have been no unusual circum-

A reference to Figs. 12A and 14 will show that the boiler drum had fractured along the longitudinal seam on the left hand side looking towards the smoke box, and it was found that the fracture was most marked at a point

about 12 or 15 inches from the front tube plate. When the side plate fractured, it was obviously thrown violently off to the right, tearing away the rivets on the circumferential seam at the smoke box end, and ripping through the material of the top plate at the fire box end. The fracture, in this case, occurred in the inner plate of the lap joint and along the line of the inner row of rivets. There was, of course, a good deal of incidental damage done to the stays and other internal fittings of the boiler, but a minute examination of the whole of these made it clear that they were secondary effects, and in no way the primary cause of the failure of the boiler.

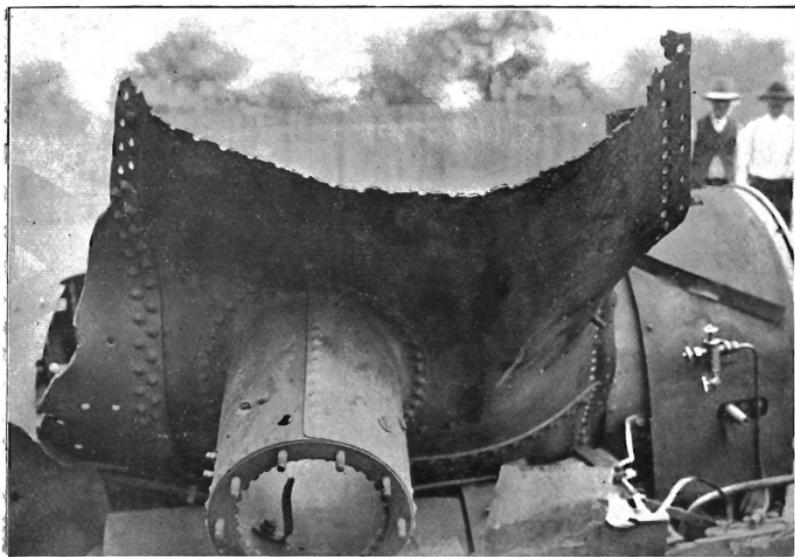
FIG. 12B.—Burwood Boiler from Outside.

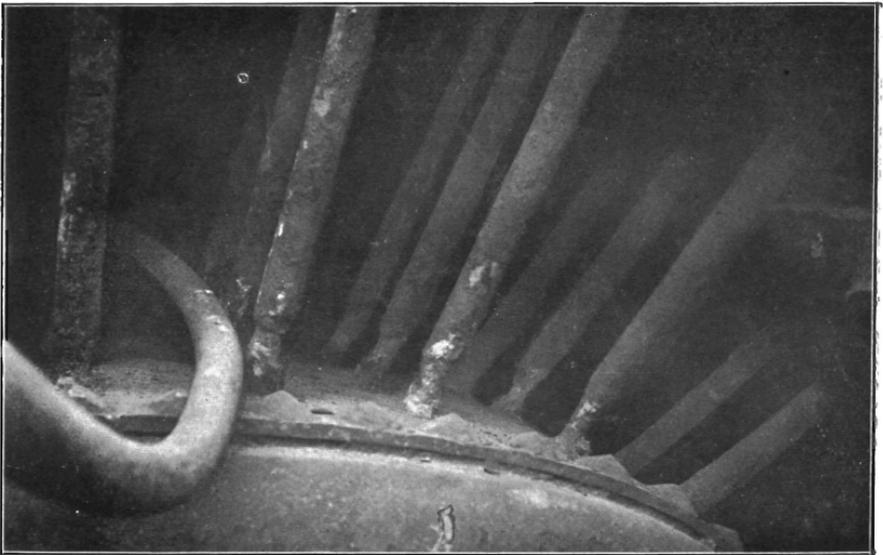
FIG. 13.—Furnace crown stays showing corrosion.

when the boiler was being re-tubed. An examination of the interior of the boiler after the explosion showed that a good deal of corrosion had been going on; many of the stays supporting the furnace crown and in the water legs being greatly reduced in section (see Fig. 13). The only openings around the fire box were at the bottom corners where the wash-out plugs were fitted, there being no inspection doors in the fire box side to allow of the stays and the furnace crown being observed. There was a marked amount of grooving on the

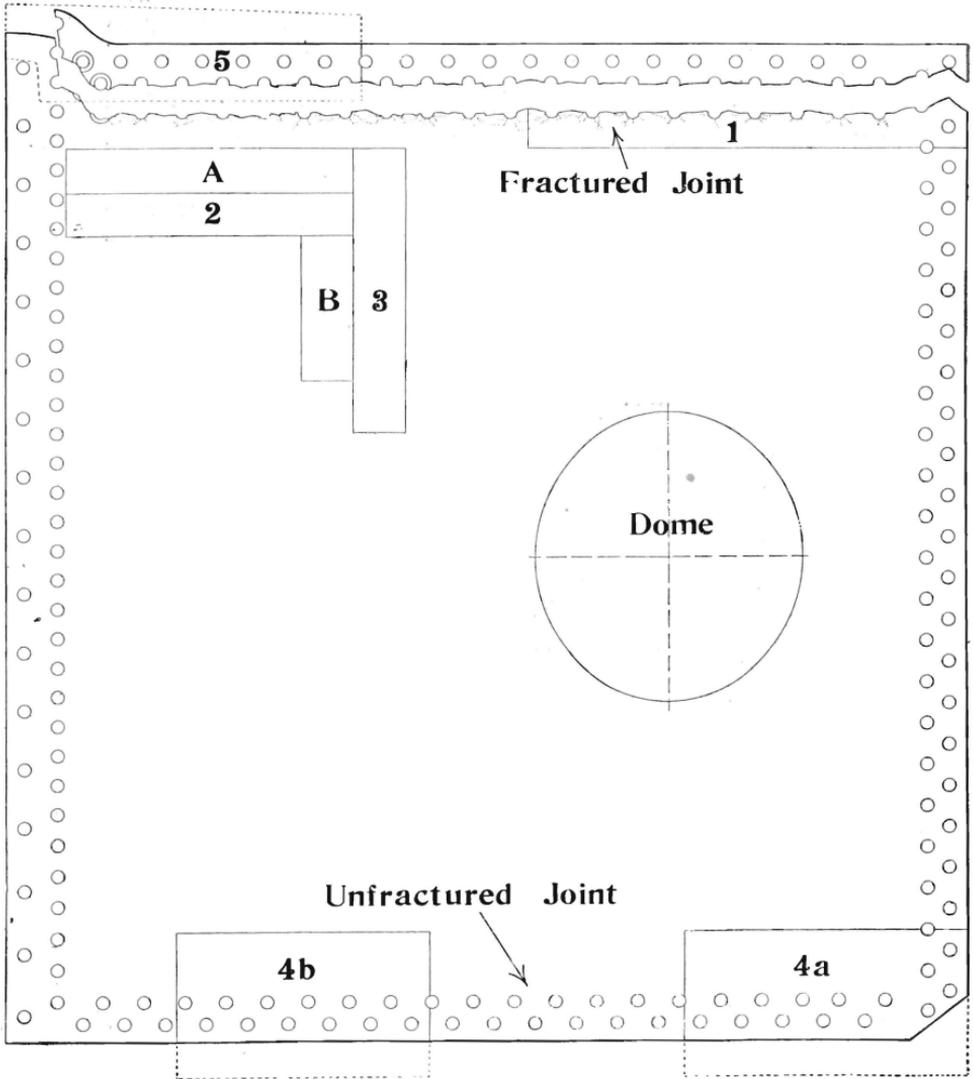
13. *Character of Fractured Plate and Results of Tests.*—An examination of the fractured plate in the Burwood boiler was made on the same lines as were adopted in the Thornton boiler. The diagram, Fig. 14, shows the position of the fracture which is seen to follow more or less closely the inner line of rivet holes of the inner (i.e., the crown) plate of the drum. Numerous smaller cracks are visible, these being due largely to the injury to the plate caused by punching the rivet holes. That the punching had an extremely bad initial effect on the plate was evident also by an examination of the corresponding unfractured joint on the other side of the boiler. The rivets were cut out of this opposite joint and the edge of the plate bent back slightly under the hydraulic press, when it was evident that there were cracks here and there along this line of rivet holes also.

FIG. 14.—Inside View of Burwood Boiler Plate.

Burwood case. The crack may be a very distinctly marked line (usually at the edge of the landing) with very few subsidiary cracks (Thornton, Fig. 2), or may be distributed irregularly along the joint (usually following more or less the rivet holes) and with many secondary cracks (Burwood case, Figs. 14 and 14A). The dotted lines (Fig. 15) showing approximately the extreme fibre stress for both surfaces, indicate that in each case the crack passes from the surface of high tension towards the surface of compression or low tension.\*

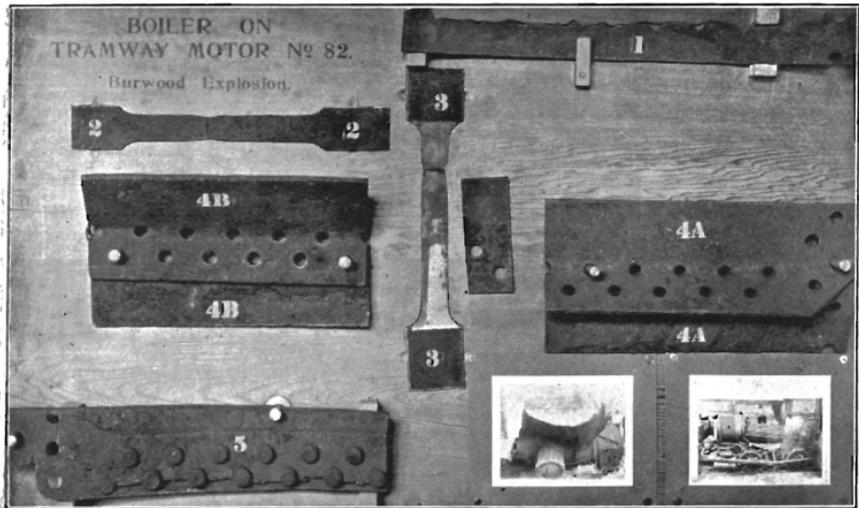
FIG. 14A.—Board of Exhibits—Boiler No. 82.

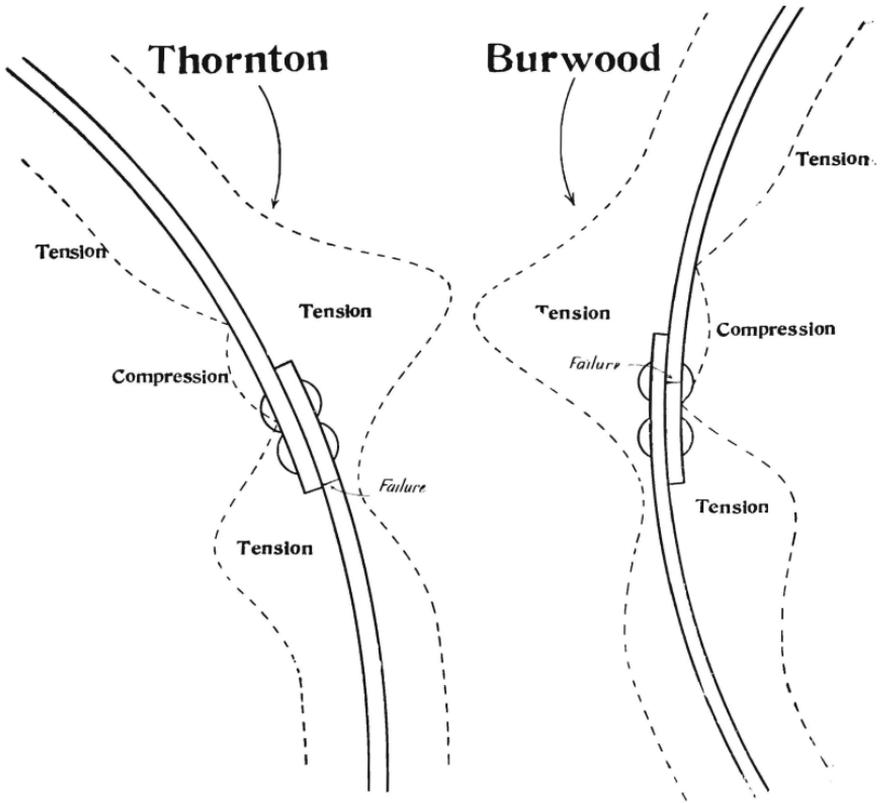
14. *Comparison of the Two Explosions.*—A brief comparison of these two boiler explosions will be interesting, as they exhibit nearly all the characteristic features usually appearing in such failures (see Fig. 15 and Figs. 2 and 14). The crack starts always from inside the joint, and may proceed outwards as in the Thornton case, or inwards as in the

FIG. 15—Comparison of the Two Explosions.

(a) The failure in each case was due primarily to the high surface stress which is the characteristic condition obtaining in all examples of lap joints. The failures were not due to any defect in the quality or structure of the material of the plate.

(e) Above all things the one conclusion to which any reasonable observer of facts would come, is that riveted lap joints should not be employed under any circumstances in boiler construction.
