BOILER EXPLOSIONS AS AFFECTED
BY UNSYMMETRICAL RIVETED JOINTS.

TYPICAL LAP JOINT BOILER EXPLOSIONS.

By S. H. BARRACLOUGH and A. J. GIBSON.

2. *General description of the Thornton Locomotive Boiler Explosion.*—The first of the two boiler failures referred to occurred near Thornton, N.S.W., on December 5th, 1905, while the engine was running in ordinary service between Maitland and Newcastle. The accident occurred on a down grade when the speed of the train was approximately 40 miles an hour. All the evidence points to the fact that there was no unusual circumstance about the running of the engine prior to the accident. The boiler was carrying its normal pressure of 140 lbs. per square inch, and the safety valves were blowing freely. Subsequent to the accident, the steam gauge and the safety valves were removed from the locomotive and tested, and were all found to be correct and in good order.

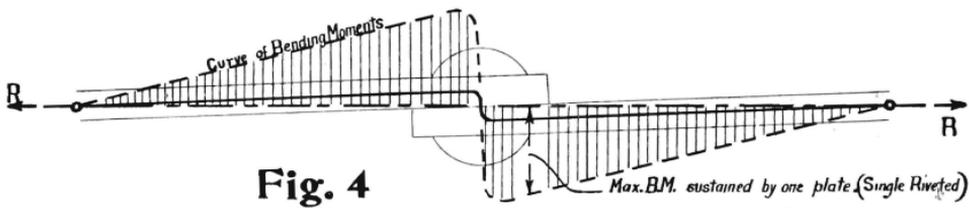
For the sake of precision, consider the case of a joint occurring in two flat plates (Fig. 3), and assume that we can find places equidistant on either side of the joint where no bending exists, i.e., where we have only an axial pull. This condition of axial pull is found, for instance, in an ordinary testing machine between the two main pin connections. The method of jointing the plates cannot affect the bending moment imposed so long as the joint is rigid; we can, therefore, consider that the two plates are all one piece,* allowing for inefficiency of the joint and such disturbing factors as curvature of the plates, etc., in the final statement of stresses.

$$F \pm f = \frac{P}{bt} (1 \pm 3)$$

that is a tension of four times the direct stress on the inner side of each plate, and a compression of twice the direct stress on the outer side of each plate.
